Ken Laibowitz  
Senior Inspector

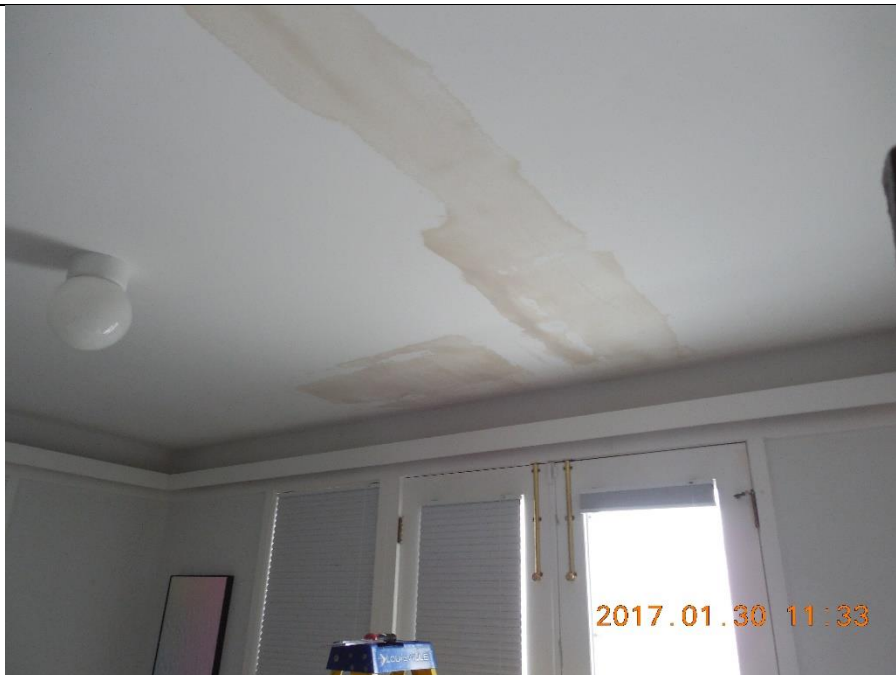
Leak, first floor ceiling, west end under deck and door above.

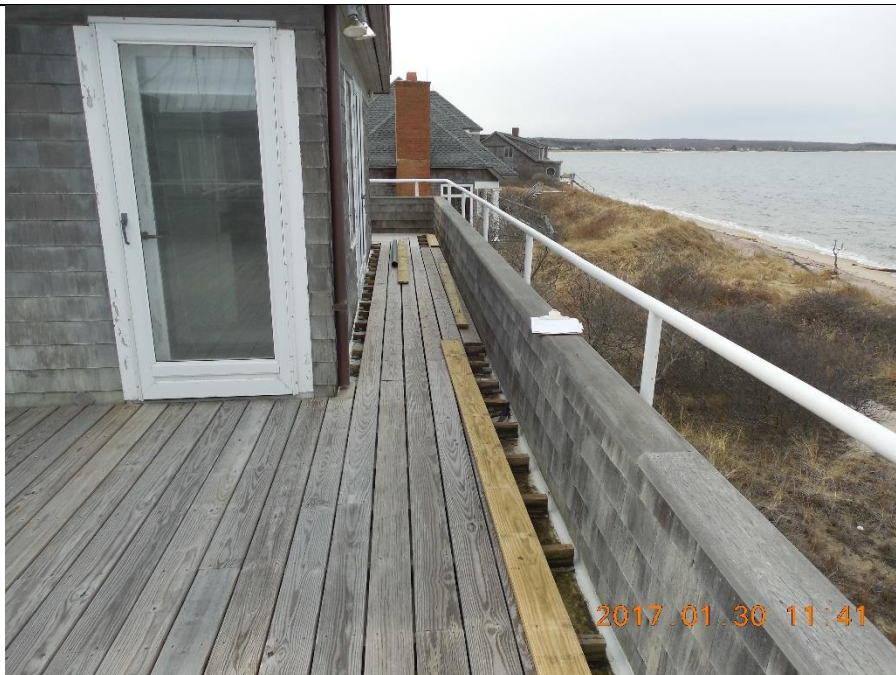
Overview of wood deck and roof over leak at west end.

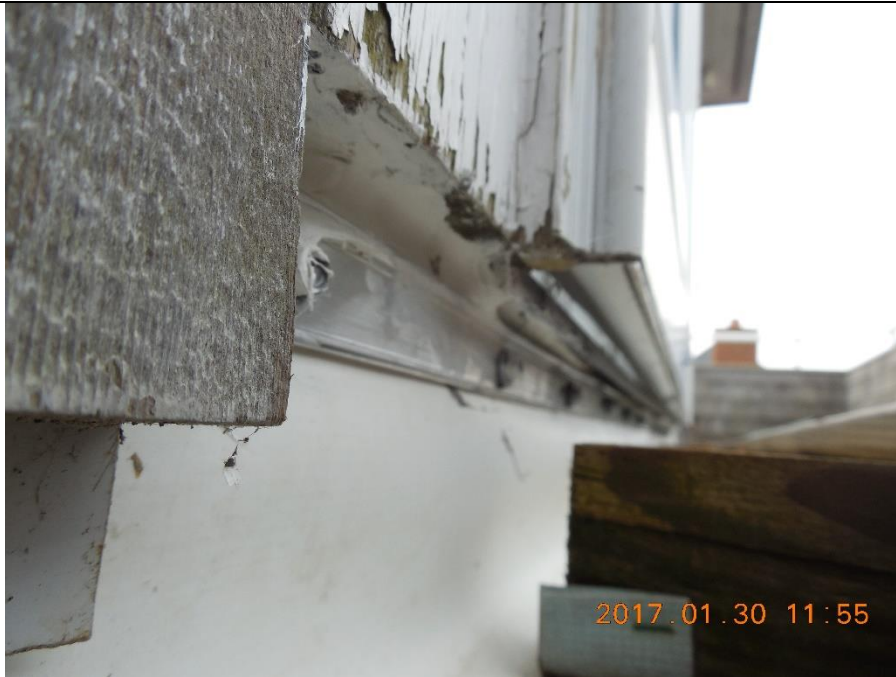
Termination bar installed just prior to my inspection at door over west end leak.

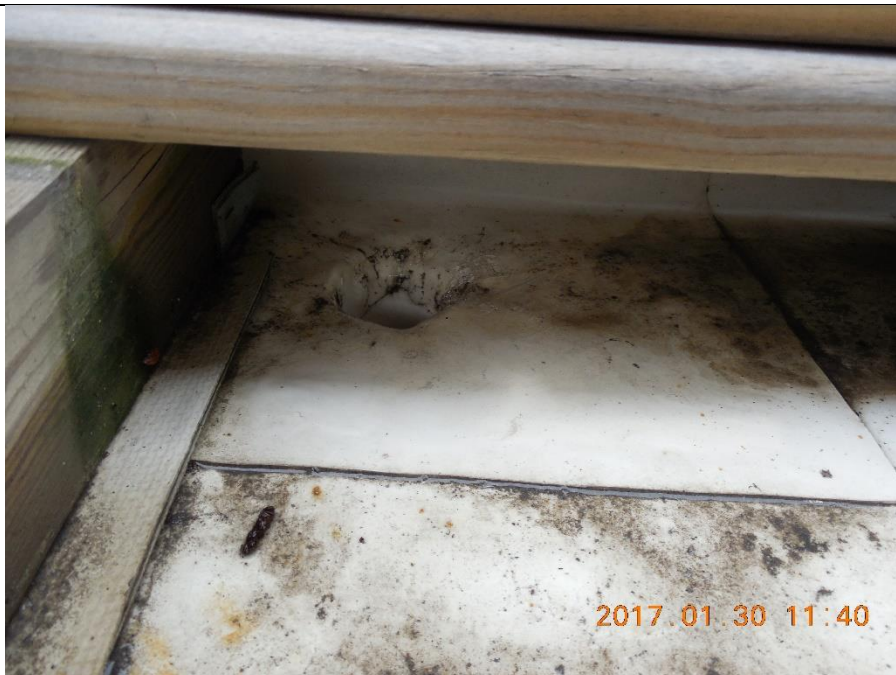
View of drain in close proximity to west end leak. Drain has been elevated due to excessive layers of membrane.

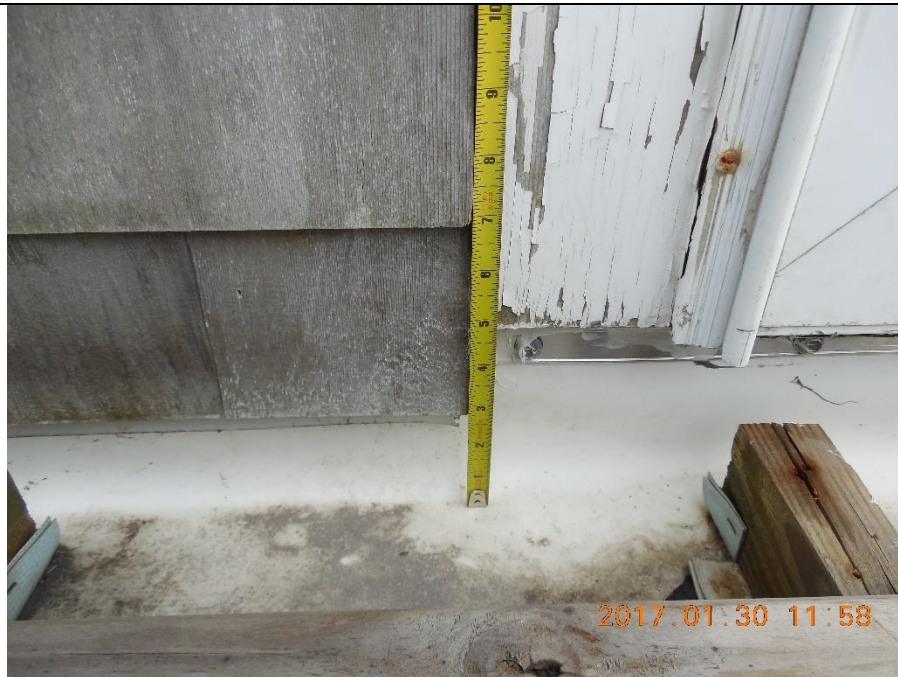
Insufficient membrane height at door jam, west end.

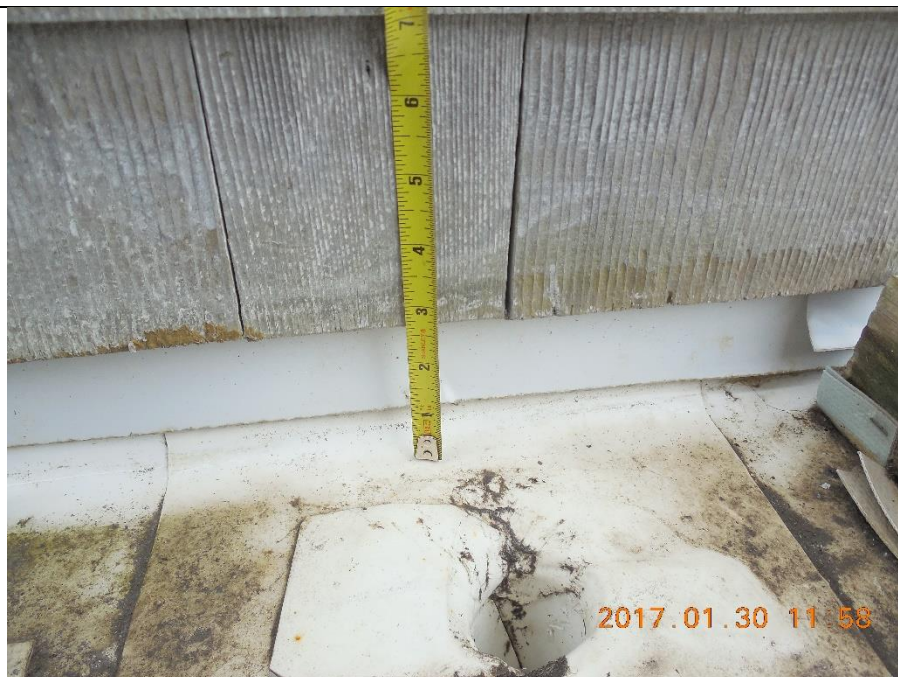
membrane. There appeared to be no sealant used to prevent water from entering behind this top cut edge of the membrane. There was, in some locations, a 3-inch wide strip of aluminum slipped in under the wood siding and over the top edge of the roof membrane. This aluminum strip was a meager and insufficient attempt to construct a proper counter flashing. Single ply roof manufacturers typically require a minimum of 8 inches of membrane flashing up a wall (or a membrane height above anticipated water levels). The roof proposal included 'up to 12"' of flashing membrane on the walls. This would have been a proper flashing height for Northeast U.S. weather conditions. To extend the membrane properly up the wall would have required removing the wood shingles and then reinstalling wood shingles covering the top edge of the vertical wall membrane. This was not done. No wood shingles on the wall were impacted. The membrane was terminated too low and the small aluminum strip was insufficient as a counter flashing. Water seepage is likely occurring at numerous locations at the base of the parapet wall with excessive seepage occurring during the winter months and during heavy rain.

View of typical wall flashing. Wood shingles have not been removed for proper installation of membrane. Aluminum strips installed in an attempt to construct a counter flashing. Membrane height is less than 3". Water seepage is likely to increase with every winter. Drain poorly flashed to membrane.

It is likely that water will seep behind the membrane at the base of all the walls due to the lack of membrane height and lack of proper counter flashing. This seepage will increase over time as the adhesive holding the membrane to the wall deteriorates. Seepage will also increase due to ice and snow buildup as is typical in Northeast. Water that seeps behind the membrane will freeze, expand, contract, and separate the membrane from the wall. Water seepage at the walls will deteriorate the wood substrate. These conditions will only get worse over time. A proper repair would include removing the wood deck, removing a minimum of 18" of wood shingles up the wall, installing a new strip of TPO membrane heat-welded to the existing roof surface and extending up the walls a minimum of 12 inches, and then reinstalling wood shingles on the wall over the top of the vertical membrane leaving 4 to 6 inches of membrane exposed at the base of the walls and then replacing the wood deck.

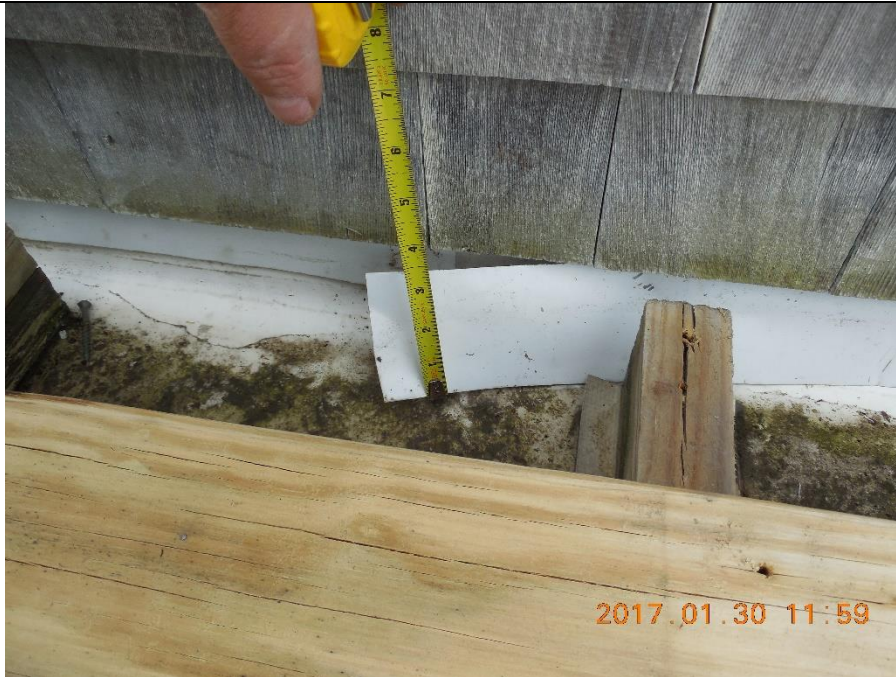
Aluminum strip is not fastened and does not provide adequate protection to the top of the membrane.

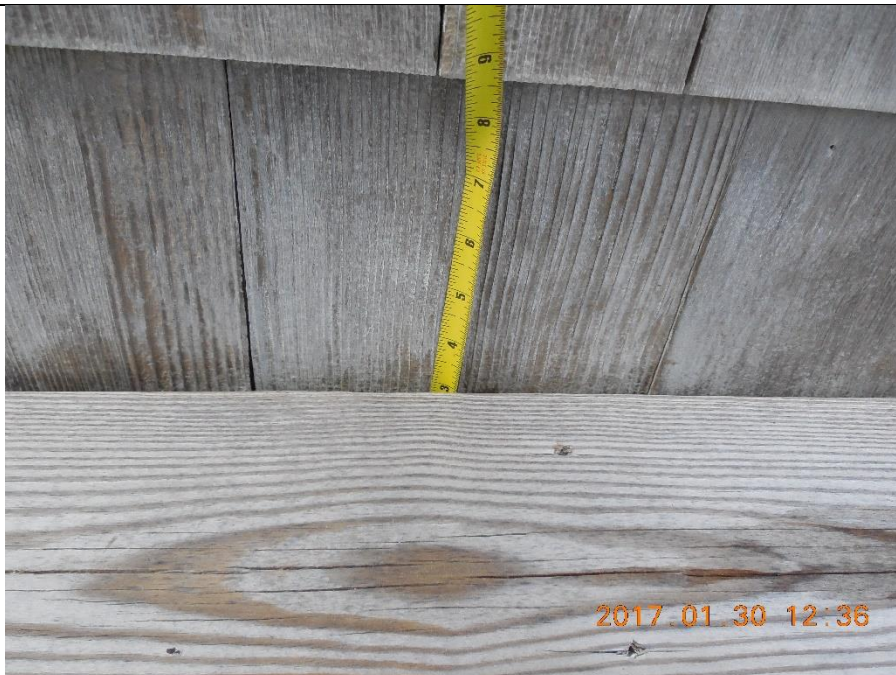
Membrane is less than 3" up wall over garage. This condition is typical at all walls.

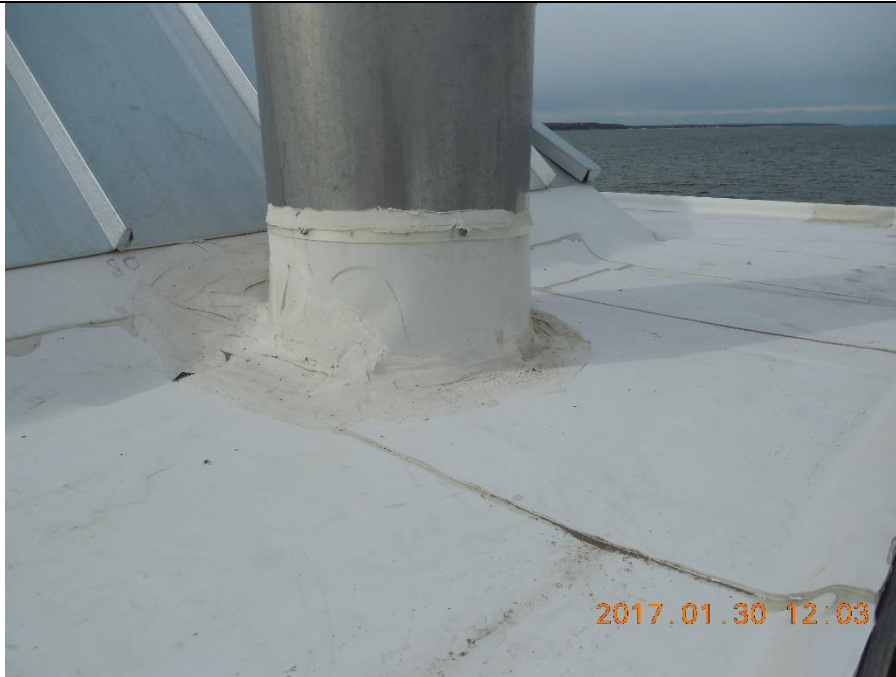
- The metal insulated flue (chimney) was flashed with excessive applications of sealant. This metal flue requires a proper pipe wrap flashing (see below Carlisle detail). The contractor apparently attempted to seal the flue penetration using only sealant. This sealant is not specified as a roof membrane or flashing and is to be use only to seal small openings and seams. Water leakage at the chimney (flue pipe) appears to be due to improper flashing of the flue penetration.

Flue over fireplace is not properly wrapped. Sealant was improperly spread all over base of flue in an attempt to prevent leakage. This sealant is not designed as a roof or flashing membrane and will not last, creating a maintenance condition. See attached detail for proper flue flashing technique.

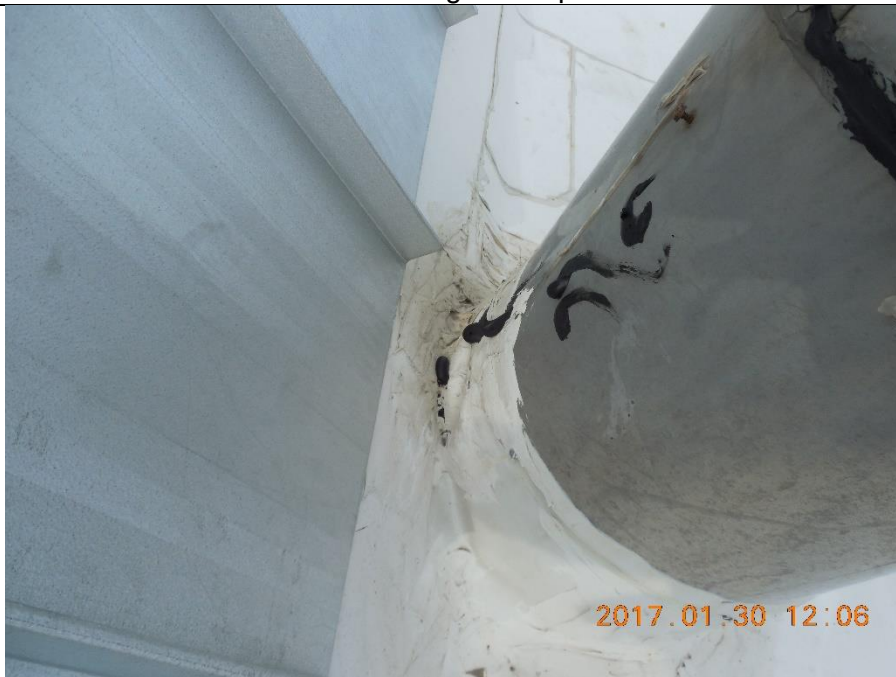
Sealant was used behind flue. Again, a maintenance condition was created.

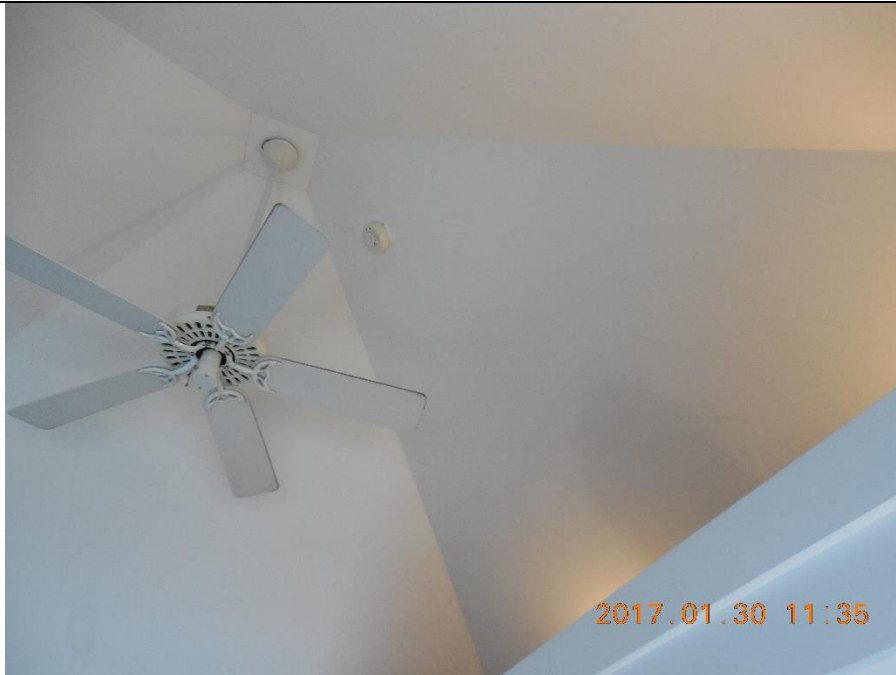
Moisture stains on cathedral ceiling in east end bedroom.

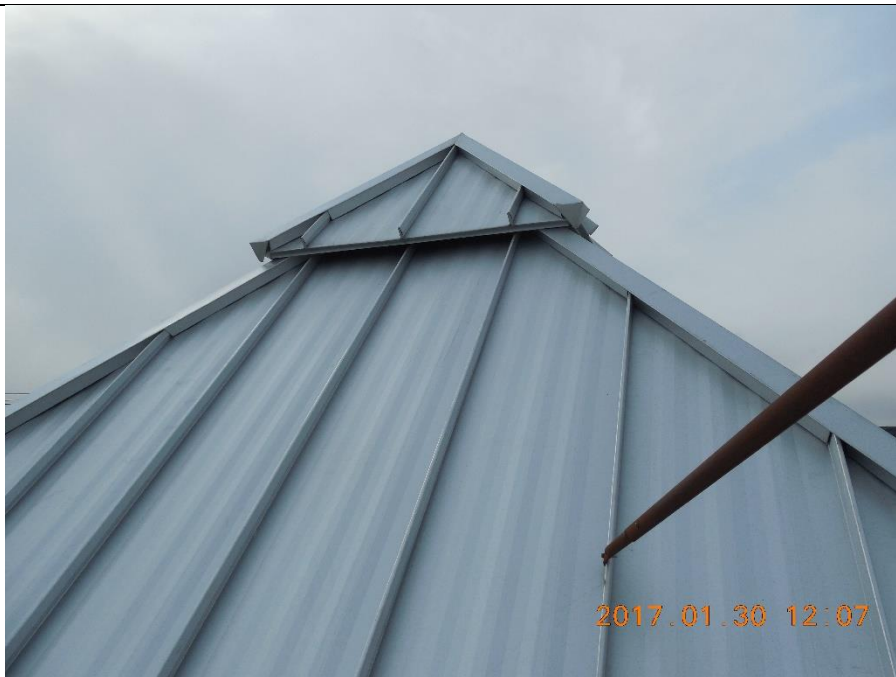
Metal panel roof over east end bedroom. Peak vent system.

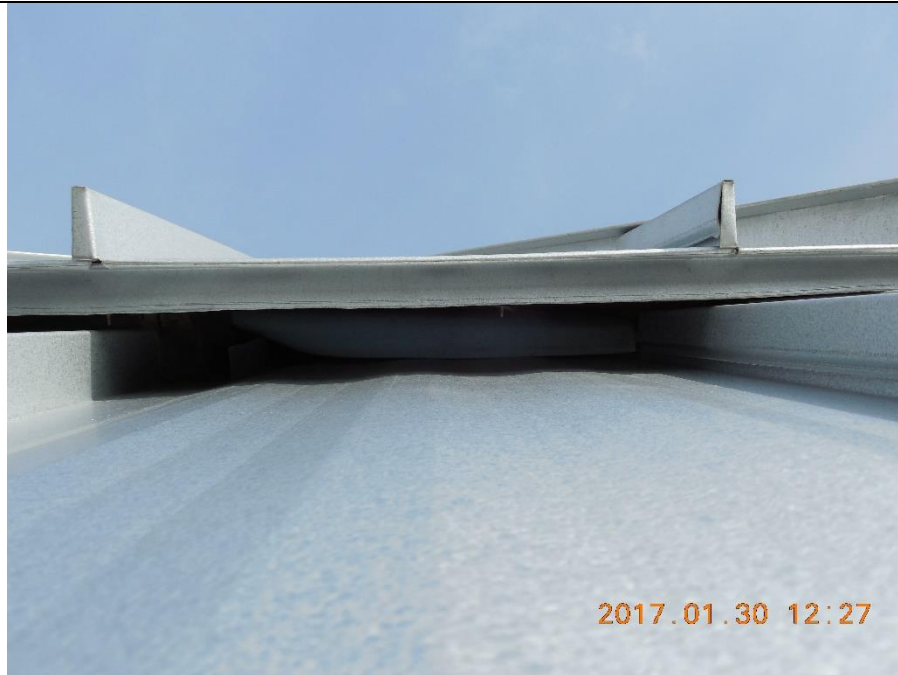
- The steep slope metal roof over the east bedroom has a ventilation system incorporated into the structure. This roof ventilation is required due to the cathedral ceiling below. Proper ventilation is required to prevent heat and moisture from being trapped in the cathedral ceiling. A proper vent in the wood soffit at the bottom of the steep roof slopes was installed when the house was constructed. The vent at the top of the roof slopes was constructed by cutting an opening in the roof sheathing, terminating the roof panels at the opening and then constructing a small raised roof section at the top of the pyramid overhanging the lower roof panels and opening in the roof sheathing. This is a standard and accepted venting detail for this type of roof system. However, because the opening in the sheathing is on the same plane as the roof panels, windblown precipitation can infiltrate into the opening in the roof sheathing. A proper ridge vent detail for a metal panel roof requires some sort of block against windblown precipitation. Often the panels are "boxed" at the tops by bending the top of the panel vertically or a separate metal closure is installed at the top of the panels under the ridge. This method prevents windblown precipitation from easily entering in the opening that is on the same plane as the panels. Air will still be able to vent up and over the closure or boxed end of the panels (see below detail for a similar ridge vent on metal panel roofs).

No protection from windblown precipitation at vent system. Top of pan was not boxed up as shown in detail below with a "bread pan" fold. No vertical closure was installed on panels below vent opening in the deck.
